**Flood Control Project Maintenance  
Levee Inspections**  
**LMA District Cover Sheet**  
**Spring 2017 Levee Inspection Results**

**Reclamation District No. 0010 Honcut**

**Spring 2017 Levee Inspection Results**

Waterway			Bank	Unit Miles
Unit No. 01 Simmerly Slough			Right	7.65
	Spring (March - May)	Summer (June - August)	(September - November) Fall	Winter (December - February)
Unit Maintenance Rating (Fall Only)				
Date of Inspection	4/11/2017 - 4/11/2017			
DWR Inspector	Sterling York			
Accompanied By	Finlay Williams

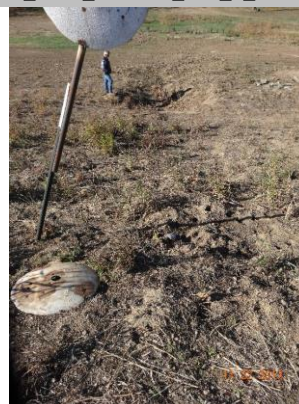
Photo 1 of 1 : SP\_2017\_RD0010\_164\_7\_20170316\_00002.jpg

LM Start	3.60	Rating **	M	Issue No.	7
LM End	3.60	Issue Type +	Ma	Location *	LS
Category	Earthen Levee			GPS Latitude/Longitude	
				Start	End
Item	Animal Control			39.215338 °	39.215338 °
				-121.610751 °	-121.610751 °
DWR ID	DWR_RD0010_02_s_2016_7				
Comment Code					
A3 : No rodents visible, but rodent burrows visible; need to backfill and compact or grout burrows.					
Inspector Comment					
There is no rodent activity, but the holes needs to be properly backfilled. Spring 2017.

View of waterward slope--burrow activity present.

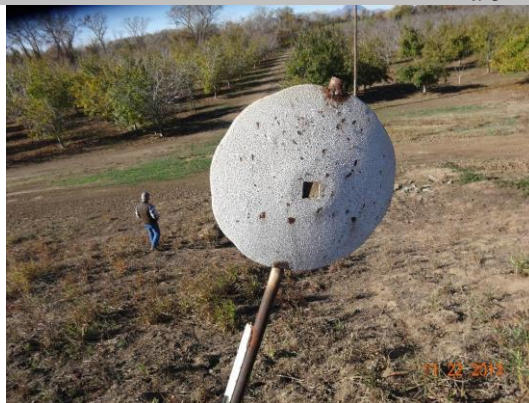
Photo 1 of 3 : UCIP\_SP\_2017\_24825\_44664.jpg

FS\_ID:24825  
 DS\_ID:21285  
 EP\_NO: N/A  
 Repair Type: Non-Urgent  
 Crossing Status: Found  
 UCIP Comments: Sediment blocking flap gate and screw gate--recommend removing material. Dense burrow activity present along levee slopes (large holes visible on landward side)--recommend addressing issue. This crossing is referenced in the USACE Periodic Inspection as item USACE\_CESPK\_HON2\_2013\_p\_0169.  
 FIELD\_STRUCT\_DESC: 30-inch CM drainpipe through the levee, 19.5 feet below the crown. Two CM cutoff walls around pipe at both shoulders. Flap gate on the waterward end. Slide gate on the landward end. Concrete headwalls at both ends. (USACE-1953). This entry matches the Drainage or Irrigation Structure referenced in O&M manual (Station 277+00).  
 FS Date: 4/30/2013

Marker visible on waterward side.

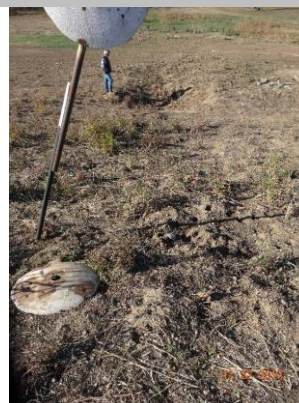
Photo 2 of 3 : UCIP\_SP\_2017\_24825\_44663.jpg

View of waterward slope--burrow activity present.

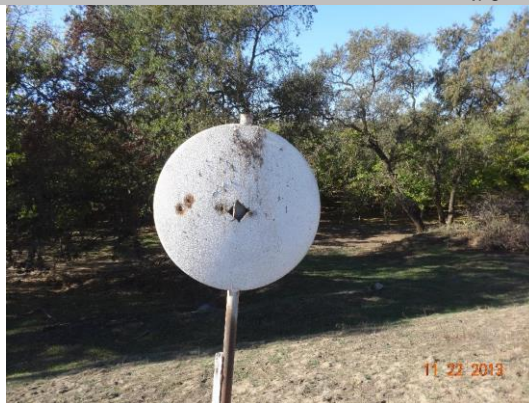
Photo 1 of 3 : UCIP\_SP\_2017\_24826\_44669.jpg

Comment Code					
Inspector Comment					
FS_ID:24826 DS_ID:21286 EP_NO: N/A Repair Type: Non-Urgent Crossing Status: Found UCIP Comments: Deformation observed on the top wall of pipe at the entrance of landward side--need to contact owner to address issue. This crossing is referenced in the USACE Periodic Inspection as item USACE_CESPK_HON2_2013_p_0180. FIELD_STRUCT_DESC: 30-inch CM drainpipe through the levee, 21.5 feet below the crown. Two CM cutoff walls around pipe at both shoulders. Flap gate on the waterward end. Slide gate on the landward end. Concrete headwalls at both ends. (USACE-1953). This entry matches the Drainage or Irrigation Structure referenced in O&M manual (Station 294+84). FS Date: 4/30/2013

View of marker located on waterward shoulder, no reference number is visible.

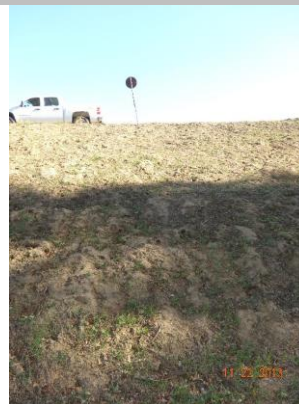
Photo 2 of 3 : UCIP\_SP\_2017\_24826\_44668.jpg

View of waterward slope.

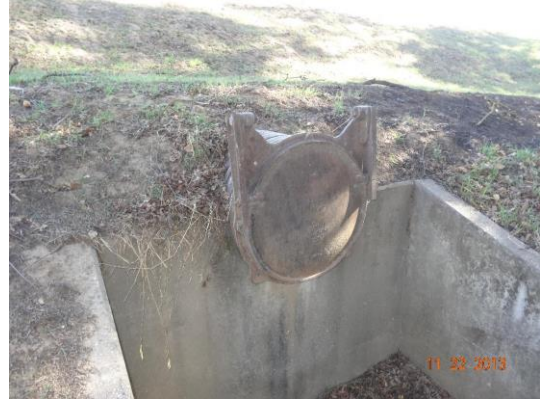
Photo 3 of 3 : UCIP\_SP\_2017\_24826\_44673.jpg

Comment Code						
Inspector Comment						
FS_ID:24826						
DS_ID:21286						
EP_NO: N/A						
Repair Type: Non-Urgent						
Crossing Status: Found						
UCIP Comments: Deformation observed on the top wall of pipe at the entrance of landward side--need to contact owner to address issue.						
This crossing is referenced in the USACE Periodic Inspection as item						
USACE_CESPK_HON2_2013_p_0180.						
FIELD_STRUCT_DESC: 30-inch CM drainpipe through the levee, 21.5						
feet below the crown. Two CM cutoff walls around pipe at both						
shoulders. Flap gate on the waterward end. Slide gate on the landward						
end. Concrete headwalls at both ends. (USACE-1953). This entry						
matches the Drainage or Irrigation Structure referenced in O&M manual						
(Station 294+84).						
FS Date: 4/30/2013

View of flapgate on concrete head wall on waterward side.

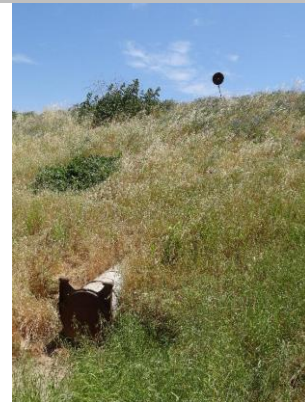
Photo 1 of 3 : UCIP\_SP\_2017\_24751\_44375.jpg

Comment Code					
Inspector Comment					
FS_ID:24751 DS_ID:21288 EP_NO: N/A Repair Type: Non-Urgent Crossing Status: Found UCIP Comments: Need to updated photos showing cleared slopes. This crossing is referenced in the USACE Periodic Inspection as item USACE_CESPK_HON2_2013_p_0193. FIELD_STRUCT_DESC: 24-inch CM drainpipe through the levee, 19.0 feet below the crown. Two CM cutoff walls around pipe at both shoulders. Flap gate on the waterward end. Slide gate on the landward side. Concrete headwall, saddle and apron on the waterward end. (USACE-1953). This entry matches the Drainage or Irrigation Structure referenced in O&M manual (Station 322+25). FS Date: 4/30/2013

View of waterward side--dense vegetation on slope.

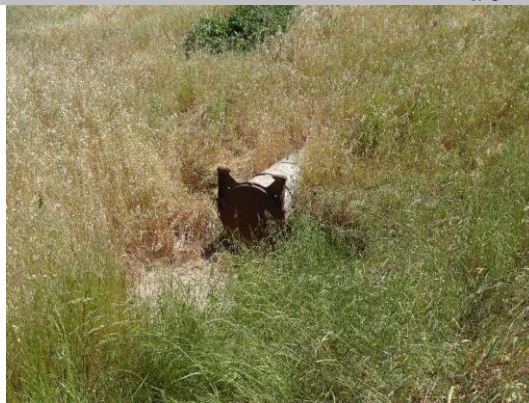
Photo 2 of 3 : UCIP\_SP\_2017\_24751\_44376.jpg

View of flap gate on waterward side.

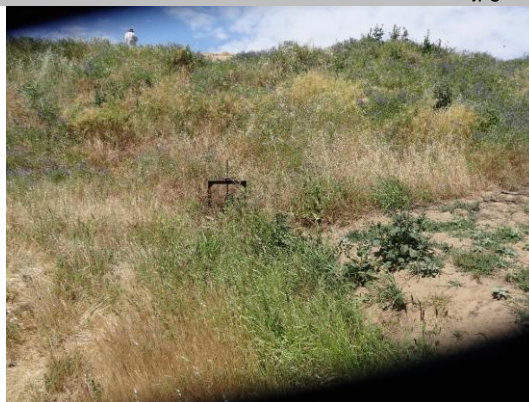
Photo 3 of 3 : UCIP\_SP\_2017\_24751\_44373.jpg

View of landward side--dense vegetation.

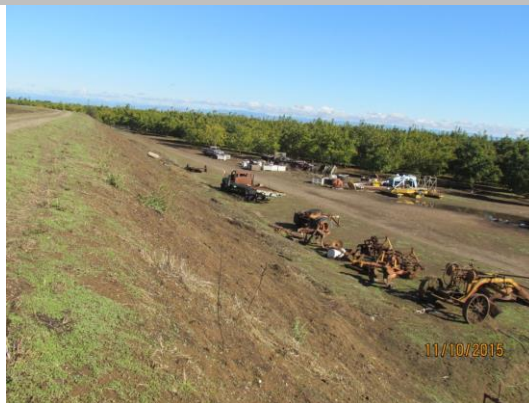
Photo 1 of 2 : SP\_2017\_RD0010\_164\_31\_20170316\_00010.jpg

View of the equipment at the toe of the levee on the landward side of the levee looking upstream. Fall 2015.

LM Start	4.44	Rating **	M	Issue No.	31
LM End	4.48	Issue Type +	En	Location *	LS
Category	Earthen Levee			GPS Latitude/Longitude	
				Start	End
Item	Encroachments			39.226946 °	39.227445 °
				-121.613048 °	-121.612718 °
DWR ID	DWR_RD0010_02_f_2015_31				
Comment Code					
EQ : Equipment					
Inspector Comment					
Remove equipment from levee toe. Spring 2017.

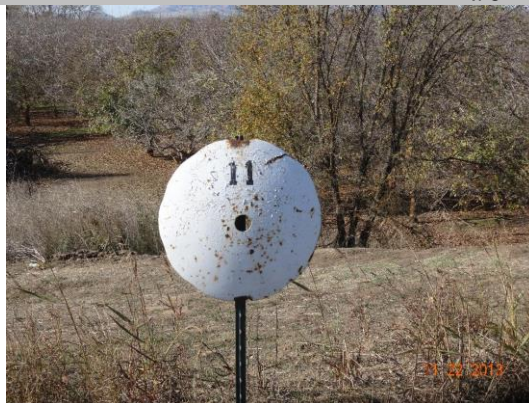
Photo 1 of 3 : UCIP\_SP\_2017\_27774\_51467.jpg

Marker visible on waterward shoulder, Reference ID No. 11 for crossing.

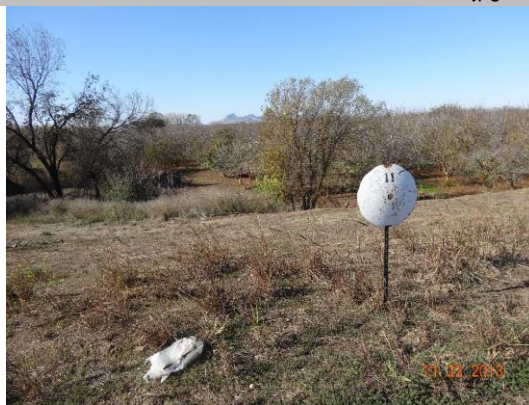
Photo 2 of 3 : UCIP\_SP\_2017\_27774\_51470.jpg

View of waterward side.

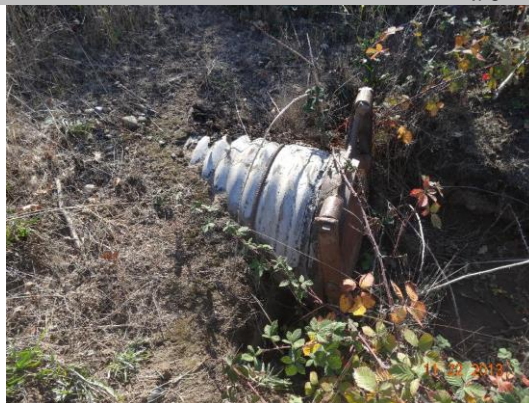
Photo 3 of 3 : UCIP\_SP\_2017\_27774\_51469.jpg

View of flap gate located on waterward side.

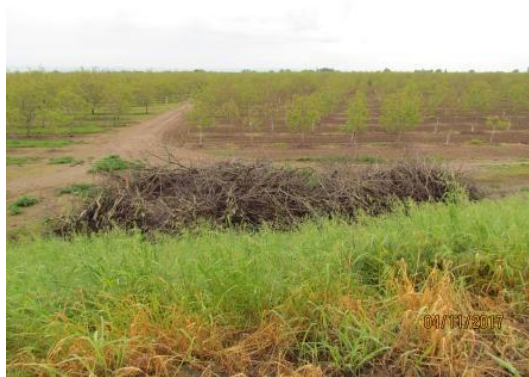
Photo 1 of 1 : SP\_2017\_RD0010\_164\_46\_20170414\_00111.jpg

View of pruning's at the landside levee toe, Spring 2017.

LM Start	4.91	Rating **	M	Issue No.	46
LM End	4.91	Issue Type +	En	Location *	LS
Category	Earthen Levee			GPS Latitude/Longitude	
				Start	End
Item	Encroachments			39.233187 °	39.233187 °
				-121.614627 °	-121.614627 °
DWR ID	DWR_RD0010_02_s_2017_46				
Comment Code					
PR : Prunings					
Inspector Comment					
Remove pruning's from levee toe, Spring 2017.

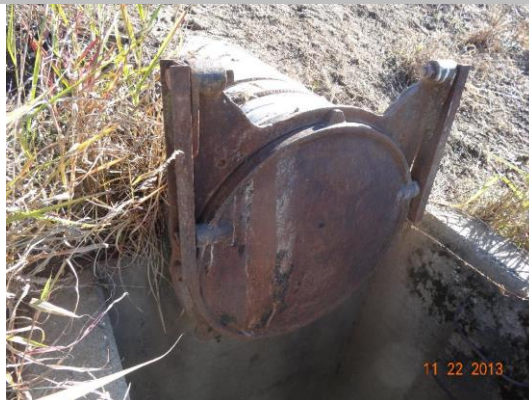
Photo 2 of 3 : UCIP\_SP\_2017\_24828\_44684.jpg

View of flap gate located on waterward side.

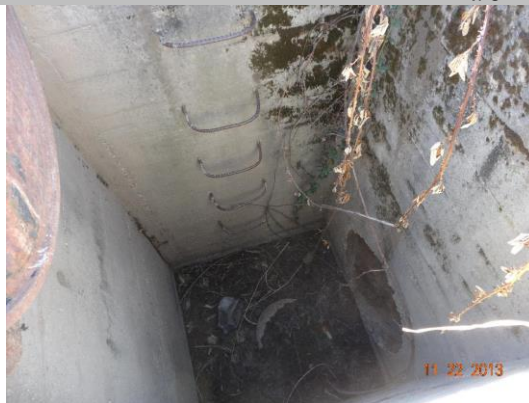
Photo 3 of 3 : UCIP\_SP\_2017\_24828\_44683.jpg

Inside view of concrete distribution box.

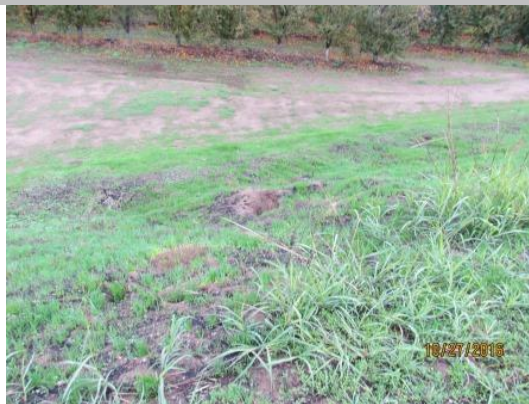
Photo 1 of 1 : SP\_2017\_RD0010\_164\_50\_20170316\_00021.jpg

LM Start	5.20	Rating **	M	Issue No.	50
LM End	5.20	Issue Type +	Ma	Location *	LS
Category	Earthen Levee			GPS Latitude/Longitude	
				Start	End
Item	Animal Control			39.237272 °	39.237272 °
				-121.615424 °	-121.615424 °
DWR ID	DWR_RD0010_02_f_2016_50				
Comment Code					
A3 : No rodents visible, but rodent burrows visible; need to backfill and compact or grout burrows.					
Inspector Comment					
No rodent activity but holes need to be properly backfilled. Spring 2017.

View of rodent hole on landside slope. Fall 2016.

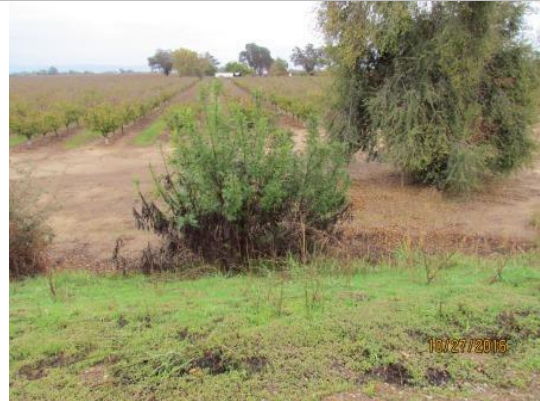
Photo 1 of 1 : SP\_2017\_RD0010\_164\_47\_20170316\_00019.jpg

View of a small tree at the toe of the landside.

LM Start	6.14	Rating **	M	Issue No.	47
LM End	6.14	Issue Type +	Ma	Location *	LS
Category	Earthen Levee			GPS Latitude/Longitude	
				Start	End
Item	Trim / Thin Trees			39.250427 °	39.250427 °
				-121.619196 °	-121.619196 °
DWR ID	DWR_RD0010_02_s_2016_47				
Comment Code					
T3 : Trim and thin trees to allow visibility of the ground and room to flood fight.					
Inspector Comment					
Remove small starter tree. Spring 2017.

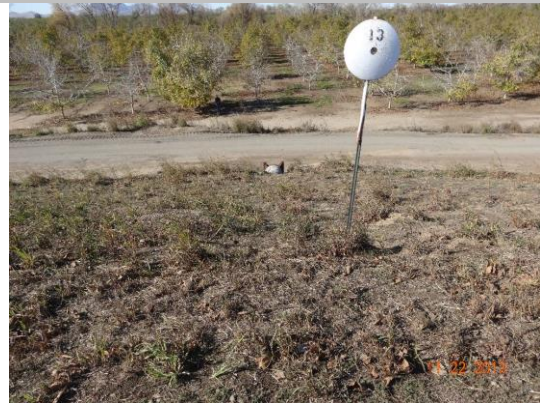
Photo 1 of 3 : UCIP\_SP\_2017\_27793\_51514.jpg

Comment Code					
Inspector Comment					
FS_ID:27793 DS_ID:21291 EP_NO: N/A Repair Type: Non-Urgent Crossing Status: Found UCIP Comments: Need to contact owner to remove debris inside concrete distribution box and on slope. This crossing is referenced in the USACE Periodic Inspection as item USACE_CESPK_HON2_2013_p_0244. FIELD_STRUCT_DESC: 30-inch CM drainpipe through the levee, 17.3 feet below the crown. Two CM cutoff walls around pipe at both shoulders. Flap gate on the waterward end. Slide gate on the landward end. Concrete headwalls at both ends. (USACE-1953). This entry matches the Drainage or Irrigation Structure referenced in O&M manual (Station 413+81). FS Date: 4/30/2013

View of marker located on waterward shoulder, pipe is reference as No. 13.

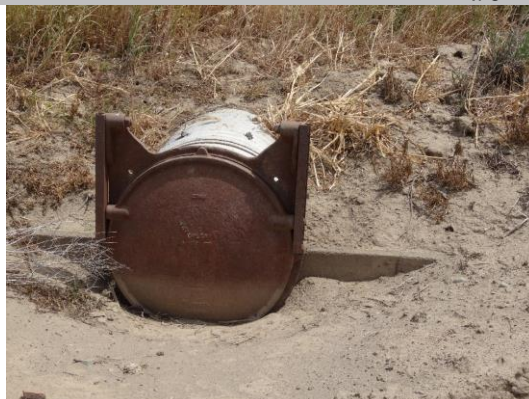
Photo 3 of 3 : UCIP\_SP\_2017\_27793\_51513.jpg

Flap gate and concrete headwall visible on waterward side.

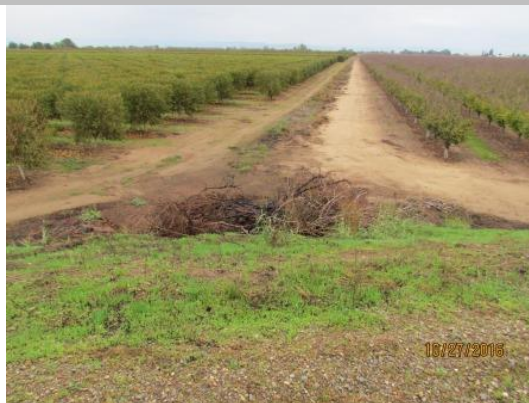
Photo 1 of 1 : SP\_2017\_RD0010\_164\_49\_20170316\_00020.jpg

View of pruning's at landside levee toe.

LM Start	6.36	Rating **	M	Issue No.	49
LM End	6.36	Issue Type +	En	Location *	LS
Category	Earthen Levee			GPS Latitude/Longitude	
				Start	End
Item	Encroachments			39.253524 °	39.253524 °
				-121.619448 °	-121.619448 °
DWR ID	DWR_RD0010_02_s_2016_49				
Comment Code					
PR : Prunings					
Inspector Comment					
Remove pruning's, Spring 2017.

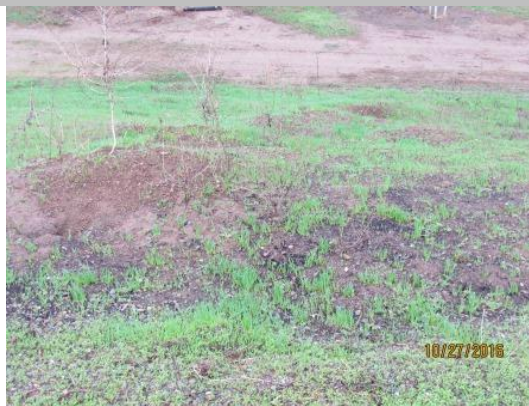
Photo 1 of 1 : SP\_2017\_RD0010\_164\_32\_20170316\_00012.jpg

LM Start	6.72	Rating **	M	Issue No.	32
LM End	6.72	Issue Type +	Ma	Location *	WS
Category	Earthen Levee			GPS Latitude/Longitude	
				Start	End
Item	Animal Control			39.257859 °	39.257859 °
				-121.617667 °	-121.617667 °
DWR ID	DWR_RD0010_02_f_2015_32				
Comment Code					
A3 : No rodents visible, but rodent burrows visible; need to backfill and compact or grout burrows.					
Inspector Comment					
No rodent activity but holes need to be properly backfilled. Spring 2017.

View of rodent holes on waterside levee slope.

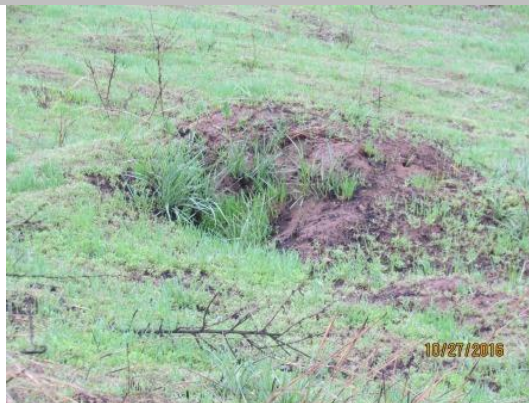
Photo 1 of 1 : SP\_2017\_RD0010\_164\_33\_20170316\_00013.jpg

LM Start	6.88	Rating **	U	Issue No.	33
LM End	6.88	Issue Type +	Ma	Location *	WS
Category	Earthen Levee			GPS Latitude/Longitude	
				Start	End
Item	Animal Control			39.259843 °	39.259843 °
				-121.616013 °	-121.616013 °
DWR ID	DWR_RD0010_02_f_2015_33				
Comment Code					
A3 : No rodents visible, but rodent burrows visible; need to backfill and compact or grout burrows.					
Inspector Comment					
Rodent hole that has more than 2 cubic feet of material, this hole is not active but needs to be backfilled properly.

View of rodent hole that has more than 2 cubic feet of material, this hole is not active but needs to be backfilled properly.

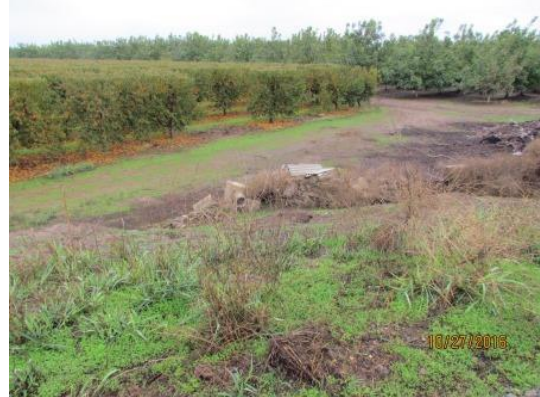
Photo 1 of 1 : SP\_2017\_RD0010\_164\_53\_20170316\_00023.jpg

View of debris at landside levee toe.

LM Start	7.07	Rating **	M	Issue No.	53
LM End	7.07	Issue Type +	En	Location *	CR
Category	Earthen Levee			GPS Latitude/Longitude	
				Start	End
Item	Encroachments			39.262290 °	39.262290 °
				-121.614390 °	-121.614390 °
DWR ID	DWR_RD0010_02_s_2016_53				
Comment Code					
DE : Debris					
Inspector Comment					
Remove debris from levee toe. Spring 2017.

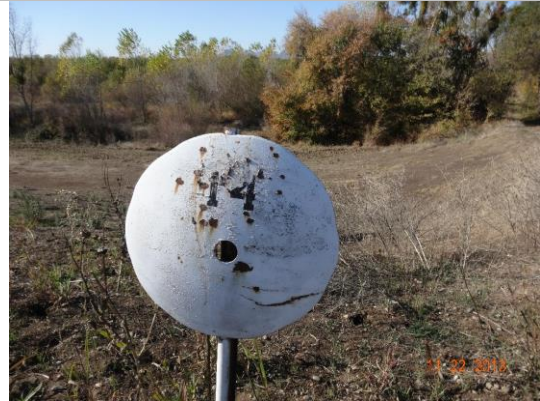
Photo 1 of 3 : UCIP\_SP\_2017\_50059\_44693.jpg

Comment Code					
Inspector Comment					
FS_ID:50059 DS_ID:21293 EP_NO: N/A Repair Type: Non-Urgent Crossing Status: Indicator Found UCIP Comments: 7/01/2016 Crossing is blocked by sediment and debris on both WS and LS. Screw gate is missing on LS. (DWR UCIP - omagana)4/30/2013 Both openings of crossing are blocked by sediment--screw gate is damage. Recommend notifying owner to repair screw gate and remove sediment build-up blocking openings. This crossing is referenced in the USACE Periodic Inspection as item USACE_CESPK_HON2_2013_p_0295. (DWR UCIP - omagana) FIELD_STRUCT_DESC: 24-inch corrugated metal drainage pipe through the levee, 13 feet below the crown. Two corrugated metal cutoff walls around pipe located on both the waterside (WS) and landside (LS) shoulders. Flap gate is located on the WS end. Slide gate is located on the LS. Concrete headwall, saddle and apron are located on the WS end. [Additional Reference(s): DWR Levee Log, 2005. USACE Sacramento O&M Manual Unit No. 151, May 1953, Station 471+21]. FS Date: 7/1/2016

Marker visible on WS shoulder, crossing referenced as No. 14.

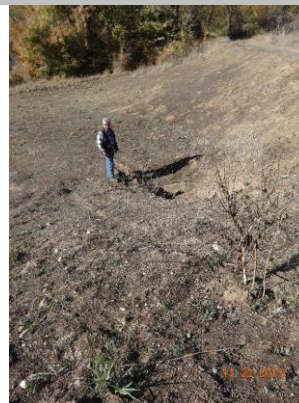
Photo 2 of 3 : UCIP\_SP\_2017\_50059\_44692.jpg

Comment Code						
Inspector Comment						
FS_ID:50059 DS_ID:21293 EP_NO: N/A Repair Type: Non-Urgent Crossing Status: Indicator Found UCIP Comments: 7/01/2016 Crossing is blocked by sediment and debris on both WS and LS. Screw gate is missing on LS. (DWR UCIP - omagana)4/30/2013 Both openings of crossing are blocked by sediment--screw gate is damage. Recommend notifying owner to repair screw gate and remove sediment build-up blocking openings. This crossing is referenced in the USACE Periodic Inspection as item USACE_CESPK_HON2_2013_p_0295. (DWR UCIP - omagana) FIELD_STRUCT_DESC: 24-inch corrugated metal drainage pipe through the levee, 13 feet below the crown. Two corrugated metal cutoff walls around pipe located on both the waterside (WS) and landside (LS) shoulders. Flap gate is located on the WS end. Slide gate is located on the LS. Concrete headwall, saddle and apron are located on the WS end. [Additional Reference(s): DWR Levee Log, 2005. USACE Sacramento O&M Manual Unit No. 151, May 1953, Station 471+21]. FS Date: 7/1/2016

View of WS slope.

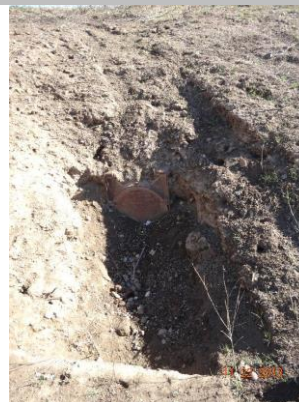
Photo 3 of 3 : UCIP\_SP\_2017\_50059\_44697.jpg

View of flap gate and concrete distribution box on WS.

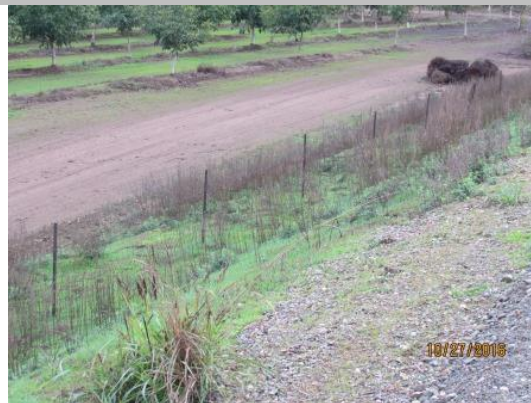
Photo 1 of 1 : SP\_2017\_RD0010\_164\_55\_20170316\_00024.jpg

LM Start	7.31	Rating **	M	Issue No.	55
LM End	11.34	Issue Type +	En	Location *	LS
Category	Earthen Levee			GPS Latitude/Longitude	
				Start	End
Item	Encroachments			39.265726 °	39.309707 °
				-121.613676 °	-121.616552 °
DWR ID	DWR_RD0010_02_s _ 2016_55				
Comment Code					
FE : Fence					
Inspector Comment					
Fence runs along landside levee toe.

View of fence at landside levee toe looking downstream.

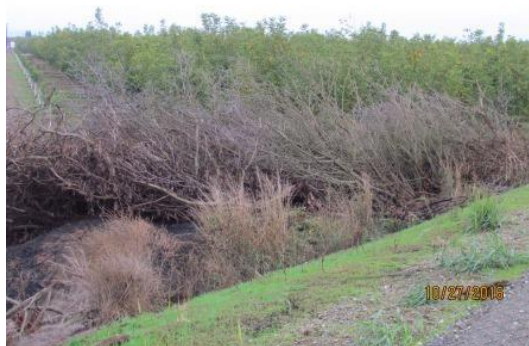
Photo 1 of 1 : SP\_2017\_RD0010\_164\_58\_20170316\_00026.jpg

LM Start	7.76	Rating **	M	Issue No.	58
LM End	7.76	Issue Type +	En	Location *	LS
Category	Earthen Levee			GPS Latitude/Longitude	
				Start	End
Item	Encroachments			39.271617 °	39.271617 °
				-121.611500 °	-121.611500 °
DWR ID	DWR_RD0010_02_s_2016_58				
Comment Code					
PR : Prunings					
Inspector Comment					
Remove pruning's from toe. Spring 2017.

View of pruning's stacked up at landside levee toe.

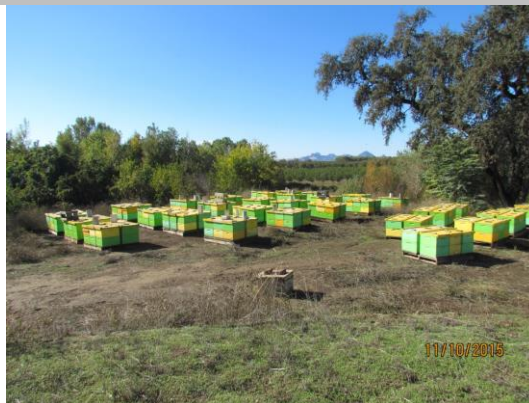
Photo 1 of 1 : SP\_2017\_RD0010\_164\_34\_20170316\_00014.jpg

LM Start	7.86	Rating **	M	Issue No.	34
LM End	7.86	Issue Type +	En	Location *	CR
Category	Earthen Levee			GPS Latitude/Longitude	
				Start	End
Item	Encroachments			39.272290 °	39.272290 °
				-121.613080 °	-121.613080 °
DWR ID	DWR_RD0010_02_f_2015_34				
Comment Code					
MA : Material					
Inspector Comment					
Bee hives have been placed on a wide section of the crown.

View of the beehives on the crown of the levee.

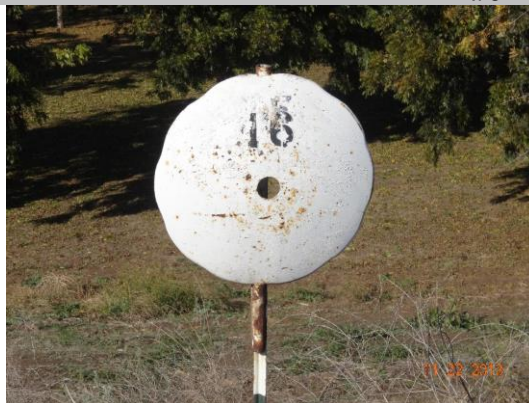
Photo 1 of 3 : UCIP\_SP\_2017\_24832\_44705.jpg

LM Start	8.06	Rating **	A/W	Issue No.	92
LM End	8.06	Issue Type +	Ma	Location *	CR
Category	Supplemental			GPS Latitude/Longitude	
				Start	End
Item	DWR UCIP LMA Responsibility			39.274890 °	39.274890 °
				-121.611526 °	-121.611526 °
DWR ID					
Comment Code					
Inspector Comment					
FS_ID:24832					
DS_ID:21295					
EP_NO: N/A					
Repair Type: No Action Needed					
Crossing Status: Found					
UCIP Comments: This crossing is referenced in the USACE Periodic Inspection as item USACE_CESPK_HON2_2013_p_0329.					
FIELD_STRUCT_DESC: 24-inch CM drainpipe through the levee, 12.5 feet below the crown. Two CM cutoff walls around pipe at both shoulders. Flap gate on the waterward end. Slide gate on the landward end. Concrete headwalls at both ends. (USACE-1953). This entry matches the Drainage or Irrigation Structure referenced in O&M manual (Station 515+52).					
FS Date: 4/30/2013

Marker visible on waterward shoulder, crossing is referenced as No. 16.

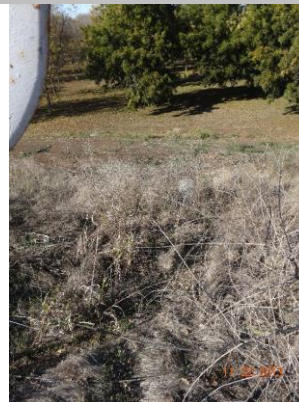
Photo 2 of 3 : UCIP\_SP\_2017\_24832\_44704.jpg

View of waterward side.

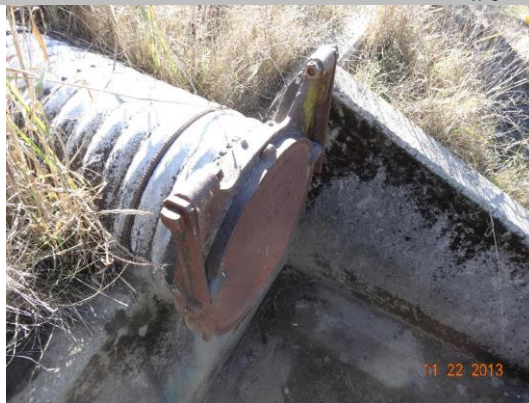
Photo 3 of 3 : UCIP\_SP\_2017\_24832\_44703.jpg

Item	DWR UCIP LMA Responsibility			39.274890 °		39.274890 °
				-121.611526 °		-121.611526 °
DWR ID						
Comment Code						
Inspector Comment						
FS_ID:24832						
DS_ID:21295						
EP_NO: N/A						
Repair Type: No Action Needed						
Crossing Status: Found						
UCIP Comments: This crossing is referenced in the USACE Periodic Inspection as item USACE_CESPK_HON2_2013_p_0329.						
FIELD_STRUCT_DESC: 24-inch CM drainpipe through the levee, 12.5 feet below the crown. Two CM cutoff walls around pipe at both shoulders. Flap gate on the waterward end. Slide gate on the landward end. Concrete headwalls at both ends. (USACE-1953). This entry matches the Drainage or Irrigation Structure referenced in O&M manual (Station 515+52).						
FS Date: 4/30/2013

View of flap gate located on waterward side.

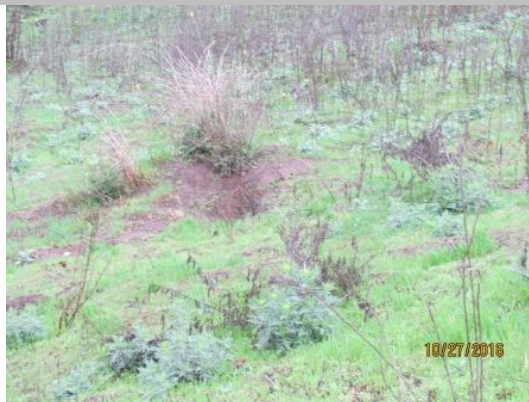
Photo 1 of 1 : SP\_2017\_RD0010\_164\_35\_20170316\_00015.jpg

LM Start	8.09	Rating **	M	Issue No.	35
LM End	8.09	Issue Type +	Ma	Location *	WS
Category	Earthen Levee			GPS Latitude/Longitude	
				Start	End
Item	Animal Control			39.275179 °	39.275179 °
				-121.611283 °	-121.611283 °
DWR ID	DWR_RD0010_02_f_2015_35				
Comment Code					
A3 : No rodents visible, but rodent burrows visible; need to backfill and compact or grout burrows.					
Inspector Comment					
No rodent activity but holes need to be backfilled, Spring 2017.

View of rodent hole on waterside.

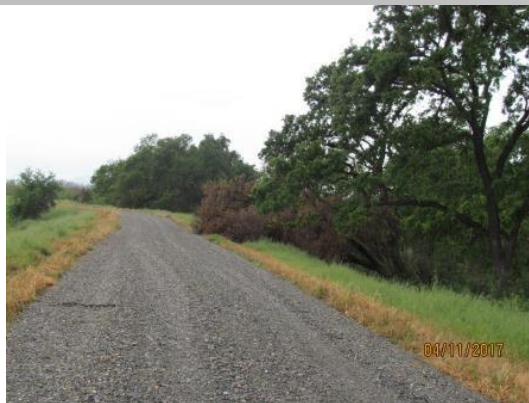
Photo 1 of 1 : SP\_2017\_RD0010\_164\_44\_20170414\_00114.jpg

LM Start	8.45	Rating **	M	Issue No.	44
LM End	8.45	Issue Type +	Ma	Location *	WS
Category	Earthen Levee			GPS Latitude/Longitude	
				Start	End
Item	Encroachments			39.278905 °	39.278905 °
				-121.607328 °	-121.607328 °
DWR ID	DWR_RD0010_02_s_2017_44				
Comment Code					
TR : Tree or limb					
Inspector Comment					
Remove fallen tree from slope, Spring 2017.

View looking downstream of a fallen tree on the waterside slope, Spring 2017.

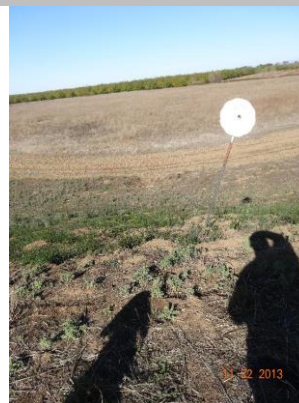
Photo 1 of 3 : UCIP\_SP\_2017\_27775\_51473.jpg

Comment Code					
Inspector Comment					
FS_ID:27775 DS_ID:21296 EP_NO: N/A Repair Type: Non-Urgent Crossing Status: Found UCIP Comments: Sediment build-up at the inlet--recommend clearing sediment. This crossing is referenced in the USACE Periodic Inspection as item USACE_CESPK_HON2_2013_p_0348. FIELD_STRUCT_DESC: 30-inch CM drainpipe through the levee, 23.0 feet below the crown. Two CM cutoff walls around pipe at both shoulders. Flap gate on the waterward end. Slide gate on the landward end. Concrete headwalls at both ends. Metal marker on waterward shoulder. (USACE-1953). This entry matches the Drainage or Irrigation Structure referenced in O&M manual (Station 551+96). FS Date: 4/30/2013

View of waterward side.

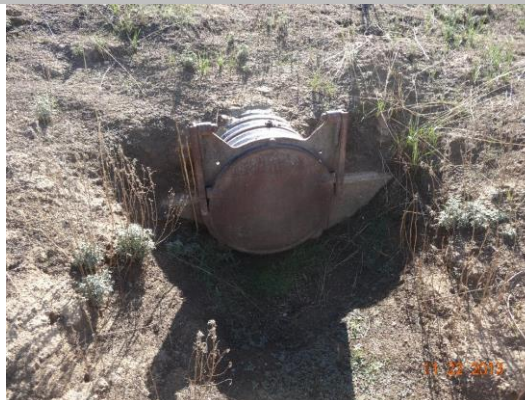
Photo 3 of 3 : UCIP\_SP\_2017\_27775\_51477.jpg

View of flap gate visible on waterward side.

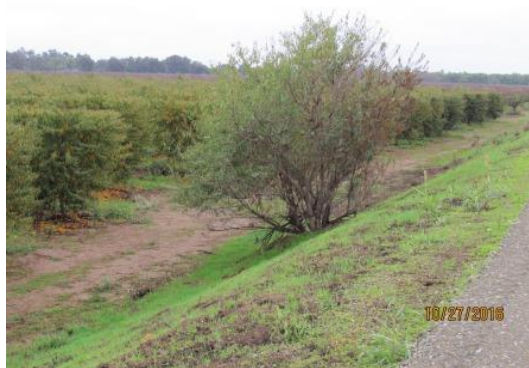
Photo 1 of 1 : SP\_2017\_RD0010\_164\_66\_20170316\_00031.jpg

LM Start	9.02	Rating **	M	Issue No.	66
LM End	9.02	Issue Type +	Ma	Location *	LS
Category	Earthen Levee			GPS Latitude/Longitude	
				Start	End
Item	Trim / Thin Trees			39.282329 °	39.282329 °
				-121.600161 °	-121.600161 °
DWR ID	DWR_RD0010_02_s_2016_66				
Comment Code					
T2 : Thin trees to allow visibility of the ground and room to flood fight.					
Inspector Comment					
Willow tree at toe should be removed.

View of small willow tree on the landside toe looking downstream that should be removed.

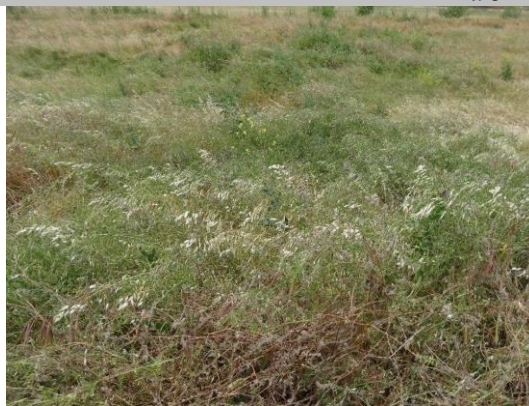
Photo 1 of 3 : UCIP\_SP\_2017\_24768\_44450.jpg

Comment Code					
Inspector Comment					
FS_ID:24768					
DS_ID:21298					
EP_NO: N/A					
Repair Type: Non-Urgent					
Crossing Status: Found					
UCIP Comments: Crossing is buried--found indicators of concrete headwall. Need to contact owner to determine status of crossing. This crossing is referenced in the USACE Periodic Inspection as item USACE_CESPK_HON2_2013_p_0378.					
FIELD_STRUCT_DESC: 24-inch CM drainpipe through the levee, 13.0 feet below the crown. Two CM cutoff walls around pipe at both shoulders. Flap gate on the waterward end. Slide gate on the landward end. Concrete headwalls at both ends. Metal marker on waterward slope. (USACE-1953). This entry matches the Drainage or Irrigation Structure referenced in O&M manual (Station 576+75).					
FS Date: 4/30/2013

View of waterward slope.

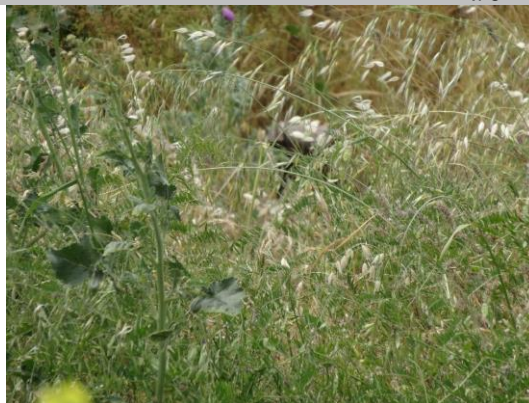
Photo 2 of 3 : UCIP\_SP\_2017\_24768\_44451.jpg

Comment Code						
Inspector Comment						
FS_ID:24768 DS_ID:21298 EP_NO: N/A Repair Type: Non-Urgent Crossing Status: Found UCIP Comments: Crossing is buried--found indicators of concrete headwall. Need to contact owner to determine status of crossing. This crossing is referenced in the USACE Periodic Inspection as item USACE_CESPK_HON2_2013_p_0378. FIELD_STRUCT_DESC: 24-inch CM drainpipe through the levee, 13.0 feet below the crown. Two CM cutoff walls around pipe at both shoulders. Flap gate on the waterward end. Slide gate on the landward end. Concrete headwalls at both ends. Metal marker on waterward slope. (USACE-1953). This entry matches the Drainage or Irrigation Structure referenced in O&M manual (Station 576+75). FS Date: 4/30/2013

Dense vegetation on landward side.

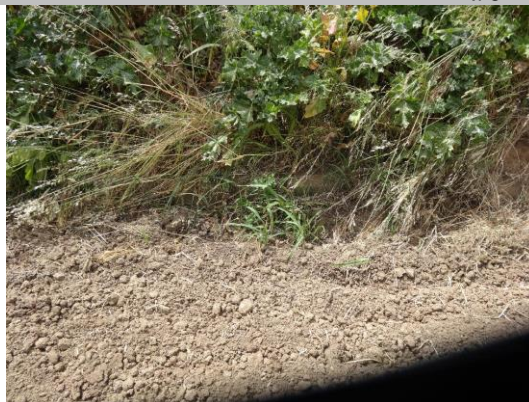
Photo 3 of 3 : UCIP\_SP\_2017\_24768\_44449.jpg

View of concrete headwall visible through dense vegetation.

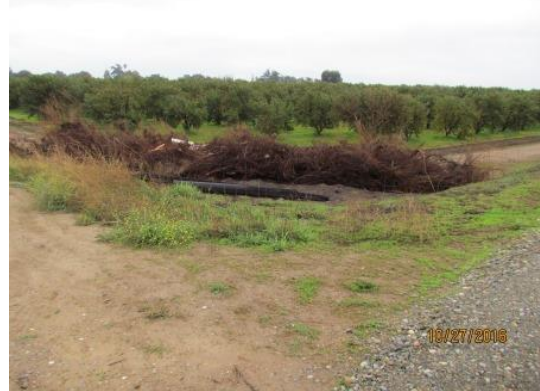
Photo 1 of 1 : SP\_2017\_RD0010\_164\_69\_20170316\_00034.jpg

LM Start	9.26	Rating **	M	Issue No.	69
LM End	9.26	Issue Type +	En	Location *	LS
Category	Earthen Levee			GPS Latitude/Longitude	
				Start	End
Item	Encroachments			39.285845 °	39.285845 °
				-121.600362 °	-121.600362 °
DWR ID	DWR_RD0010_02_s_2016_69				
Comment Code					
PR : Prunings					
Inspector Comment					
Remove pruning's from levee toe.

View of large pile of pruning's on the landside levee toe looking downstream.

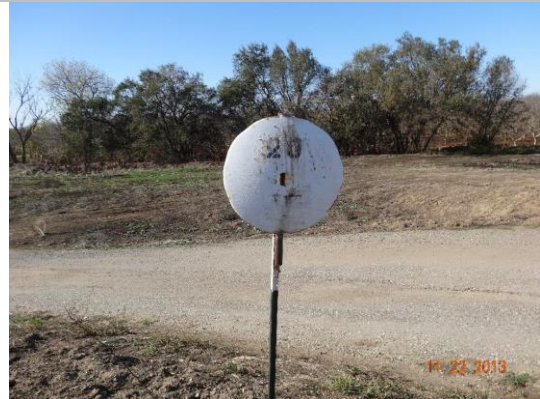
Photo 1 of 3 : UCIP\_SP\_2017\_24769\_44454.jpg

Comment Code					
Inspector Comment					
FS_ID:24769 DS_ID:21299 EP_NO: N/A Repair Type: Non-Urgent Crossing Status: Found UCIP Comments: Need to contact owner. Need to clear debris from concrete distribution box on waterward and remove debris blocking landward side.This crossing is referenced in the USACE Periodic Inspection as item USACE_CESPK_HON2_2013_p_0383. FIELD_STRUCT_DESC: 24-inch CM drainpipe through the levee, 12.0 feet below the crown. Two CM cutoff walls around pipe at both shoulders. Flap gate on the waterward end. Slide gate on the landward side. Concrete headwall, saddle and apron on the waterward end. Metal marker on waterward shoulder. (USACE-1953). This entry matches the Drainage or Irrigation Structure referenced in O&M manual (Station 582+72). FS Date: 4/30/2013

Marker visible on waterward side shoulder, crossing is referenced as No. 20.

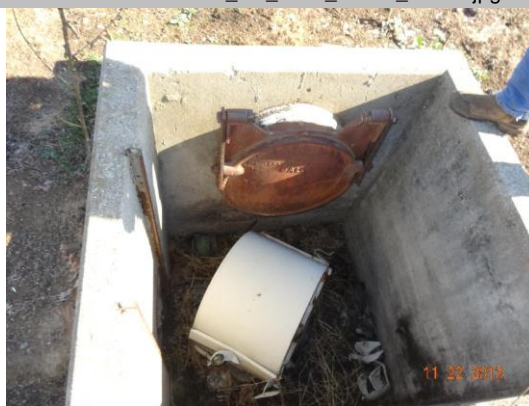
Photo 2 of 3 : UCIP\_SP\_2017\_24769\_44453.jpg

FS\_ID:24769  
DS\_ID:21299  
EP\_NO: N/A  
Repair Type: Non-Urgent  
Crossing Status: Found  
UCIP Comments: Need to contact owner. Need to clear debris from concrete distribution box on waterward and remove debris blocking landward side. This crossing is referenced in the USACE Periodic Inspection as item USACE\_CESPK\_HON2\_2013\_p\_0383.  
FIELD\_STRUCT\_DESC: 24-inch CM drainpipe through the levee, 12.0 feet below the crown. Two CM cutoff walls around pipe at both shoulders. Flap gate on the waterward end. Slide gate on the landward side. Concrete headwall, saddle and apron on the waterward end. Metal marker on waterward shoulder. (USACE-1953). This entry matches the Drainage or Irrigation Structure referenced in O&M manual (Station 582+72).  
FS Date: 4/30/2013

View of flap gate located inside concrete distribution box. Debris scattered inside box.

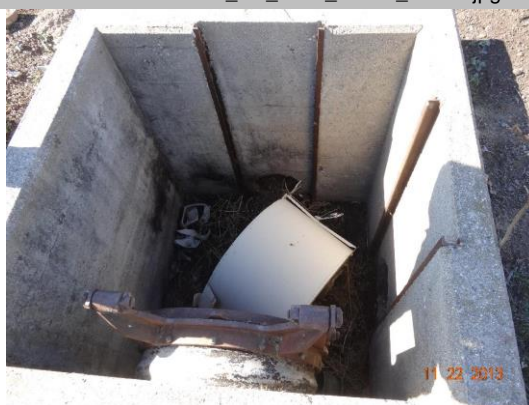
Photo 3 of 3 : UCIP\_SP\_2017\_24769\_44452.jpg

View of concrete distribution box located on waterward side.

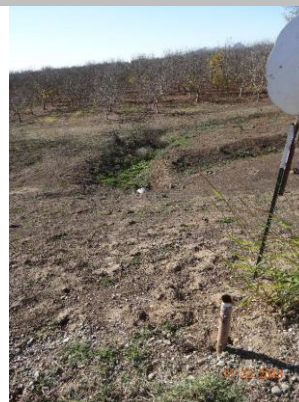
Photo 2 of 3 : UCIP\_SP\_2017\_24835\_44720.jpg

View of waterward side.

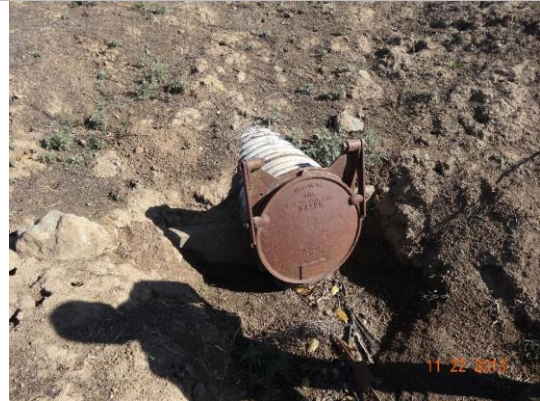
Photo 3 of 3 : UCIP\_SP\_2017\_24835\_44725.jpg

View of flap gate located on waterward side.

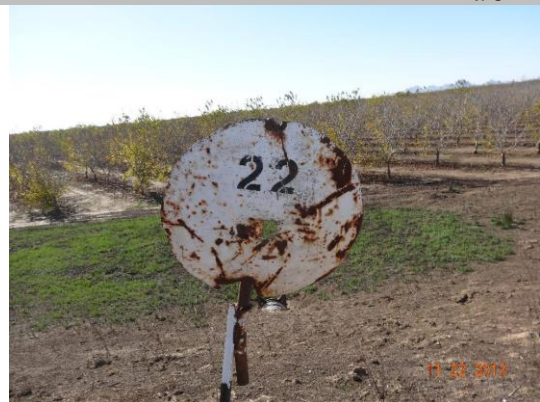
Photo 1 of 3 : UCIP\_SP\_2017\_27776\_51478.jpg

LM Start	9.71	Rating **	M	Issue No.	98	
LM End	9.71	Issue Type +	En	Location *	LS	
Category	Supplemental			GPS Latitude/Longitude		
				Start	End	
Item	DWR UCIP Field Study			39.291474 °	39.291474 °	
				-121.603677 °	-121.603677 °	
DWR ID						
Comment Code						
Inspector Comment						
FS_ID:27776						
DS_ID:21301						
EP_NO: N/A						
Repair Type: Non-Urgent						
Crossing Status: Found						
UCIP Comments: Recommend removing debris blocking slide gate on landward side. This crossing is referenced in the USACE Periodic Inspection as item USACE_CESPK_HON2_2013_p_0402.						
FIELD_STRUCT_DESC: 24-inch drainpipe through the levee, 13.0 feet below the crown. Flap gate on the waterward end. Slide gate on the landward end. Concrete headwall at landward toe.						
FS Date: 4/30/2013

Marker visible on waterward shoulder, crossing referenced as No. 22.

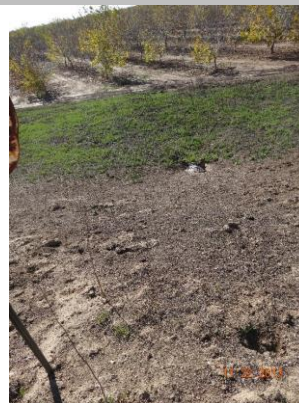
Photo 2 of 3 : UCIP\_SP\_2017\_27776\_51482.jpg

View of waterward side.

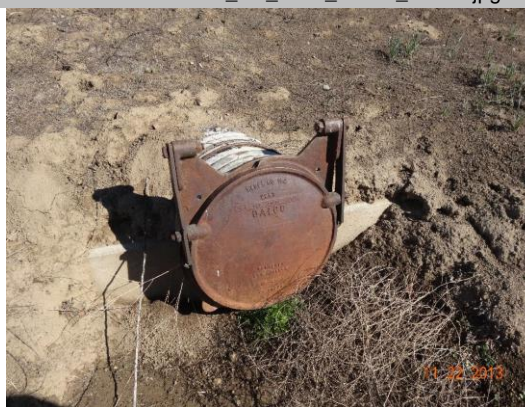
Photo 3 of 3 : UCIP\_SP\_2017\_27776\_51481.jpg

View of flap gate located on waterward toe.

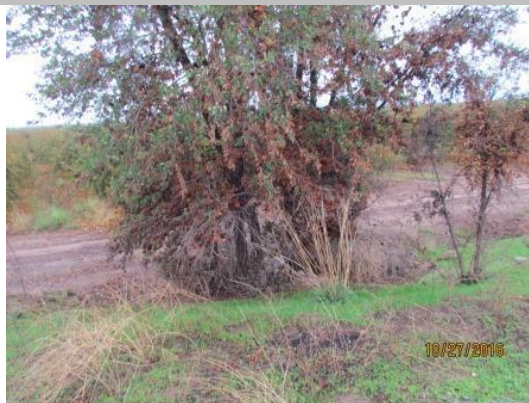
Photo 1 of 1 : SP\_2017\_RD0010\_164\_70\_20170316\_00035.jpg

LM Start	9.94	Rating **	M	Issue No.	70
LM End	9.94	Issue Type +	Ma	Location *	LS
Category	Earthen Levee			GPS Latitude/Longitude	
				Start	End
Item	Trim / Thin Trees			39.293633 °	39.293633 °
				-121.606986 °	-121.606986 °
DWR ID	DWR_RD0010_02_s_2016_70				
Comment Code					
T1 : Trim trees to at least five feet above ground level.					
Inspector Comment					
Trim tree up five feet for visibility and access.

View of tree on landside toe that need to be trimmed up five feet for visibility and access.

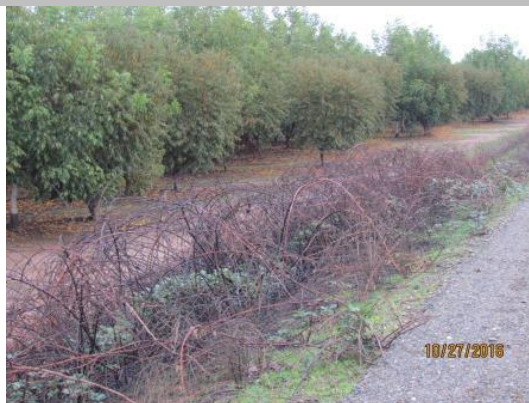
Photo 1 of 1 : SP\_2017\_RD0010\_164\_72\_20170316\_00036.jpg

LM Start	9.95	Rating **	A/W	Issue No.	72
LM End	10.30	Issue Type +	Ma	Location *	LS
Category	Earthen Levee			GPS Latitude/Longitude	
				Start	End
Item	Vegetation			39.293740 °	39.296901 °
				-121.607210 °	-121.612145 °
DWR ID	DWR_RD0010_02_s_2016_72				
Comment Code					
V2 : Remove the wild growth other than native grasses from the levee slopes.					
Inspector Comment					
Blackberry bushes have been sprayed/burned, but need to removed.

View of landside looking downstream at Blackberry bushes that have been sprayed/burned, but need to removed.

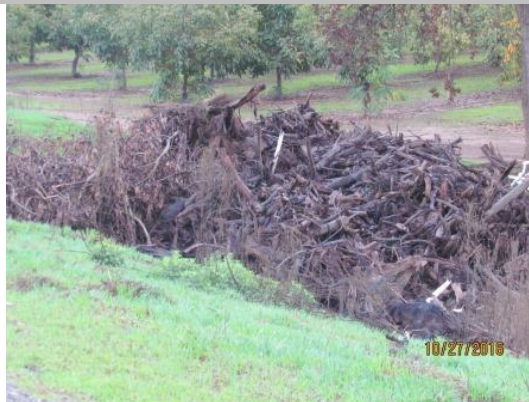
Photo 1 of 1 : SP\_2017\_RD0010\_164\_60\_20170316\_00028.jpg

LM Start	9.96	Rating **	M	Issue No.	60
LM End	9.96	Issue Type +	En	Location *	WS
Category	Earthen Levee			GPS Latitude/Longitude	
				Start	End
Item	Encroachments			39.293770 °	39.293770 °
				-121.607244 °	-121.607244 °
DWR ID	DWR_RD0010_02_f_2016_60				
Comment Code					
PR : Prunings					
Inspector Comment					
Remove pruning's from levee toe.

View of large pile of pruning's on the waterside toe looking downstream.

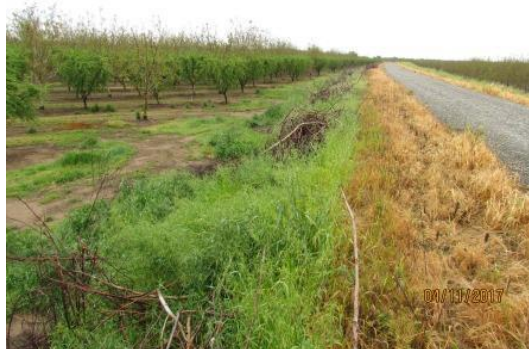
Photo 1 of 1 : SP\_2017\_RD0010\_164\_43\_20170414\_00115.jpg

LM Start	10.07	Rating **	M	Issue No.	43
LM End	10.36	Issue Type +	En	Location *	LS
Category	Earthen Levee			GPS Latitude/Longitude	
				Start	End
Item	Encroachments			39.294602 °	39.297533 °
				-121.609028 °	-121.612900 °
DWR ID	DWR_RD0010_02_s_2017_43				
Comment Code					
PR : Prunings					
Inspector Comment					
Remove pruning's from slope, Spring 2017.

View looking downstream of pruning's on the landside levee slope, Spring 2017.

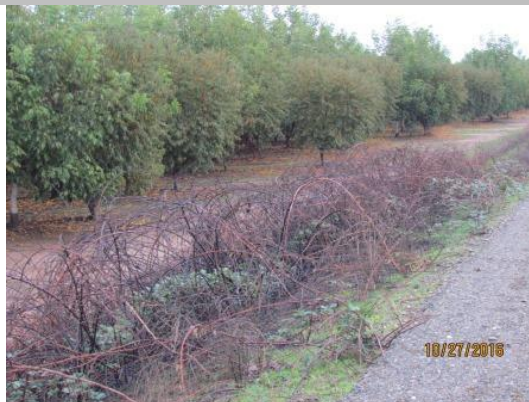
Photo 1 of 1 : SP\_2017\_RD0010\_164\_73\_20170316\_00037.jpg

LM Start	10.32	Rating **	M	Issue No.	73
LM End	10.32	Issue Type +	Ma	Location *	LS
Category	Earthen Levee			GPS Latitude/Longitude	
				Start	End
Item	Vegetation			39.297091 °	39.297091 °
				-121.612366 °	-121.612366 °
DWR ID	DWR_RD0010_02_s_2016_73				
Comment Code					
V2 : Remove the wild growth other than native grasses from the levee slopes.					
Inspector Comment					
Blackberries on landward slope should be removed.

View of landside slope looking downstream where blackberry bushes have been sprayed and burned but need to be removed.

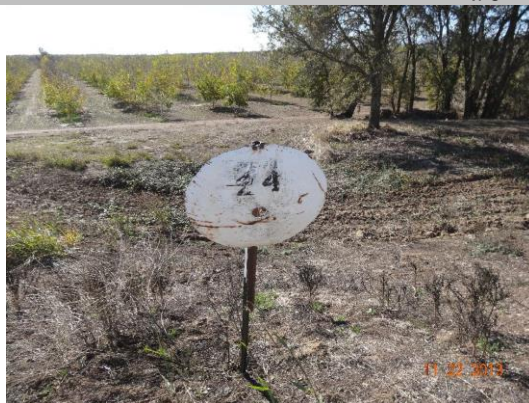
Photo 1 of 3 : UCIP\_SP\_2017\_24838\_44737.jpg

FS\_ID:24838  
DS\_ID:21303  
EP\_NO: 1069  
Repair Type: Non-Urgent  
Crossing Status: Found  
UCIP Comments: Unable to find the crossing on landward side-- indicators found of crossing. Need to coordinate with owner to determine status of crossing. If crossing is no longer in use owner will need to contact the CVFPB to comply with Title 23. This crossing is referenced in the USACE Periodic Inspection as item USACE\_CESPK\_HON2\_2013\_p\_0442.  
FIELD\_STRUCT\_DESC: 24-inch steel pipe through the levee, 13.0 feet below the crown. Two concrete cutoff walls around pipe at both shoulders. Flap gate and concrete headwall on waterward end. Slide gate and concrete saddle and apron on landward end. (Permit No. 1069-1941) This entry matches the Drainage or Irrigation Structure referenced in O&M manual (Station 638+00).  
FS Date: 4/30/2013

Marker visible on waterward shoulder, this crossing is reference as No. 24.

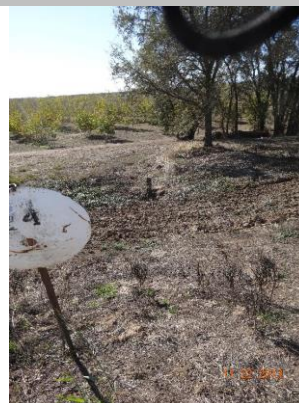
Photo 2 of 3 : UCIP\_SP\_2017\_24838\_44741.jpg

View of waterward side.

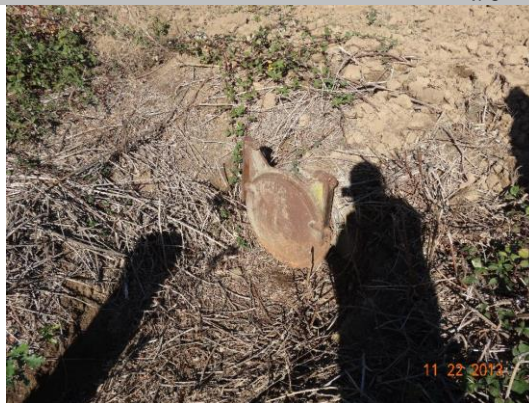
Photo 3 of 3 : UCIP\_SP\_2017\_24838\_44740.jpg

View of flap gate located on waterward side.

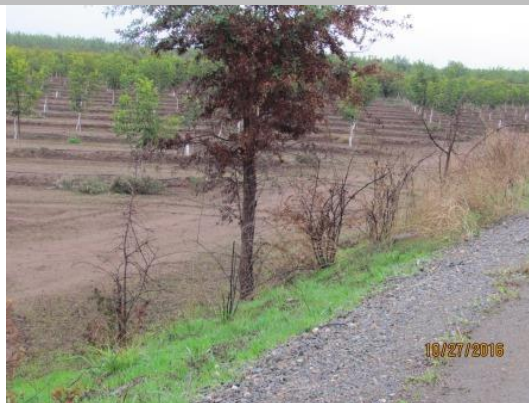
Photo 1 of 1 : SP\_2017\_RD0010\_164\_75\_20170316\_00038.jpg

LM Start	10.48	Rating **	M	Issue No.	75
LM End	10.63	Issue Type +	Ma	Location *	LS
Category	Earthen Levee			GPS Latitude/Longitude	
				Start	End
Item	Trim / Thin Trees			39.298762 °	39.300083 °
				-121.614394 °	-121.616614 °
DWR ID	DWR_RD0010_02_s_2016_75				
Comment Code					
T2 : Thin trees to allow visibility of the ground and room to flood fight.					
Inspector Comment					
Tree has been trimmed up but small starter trees should be removed. Fall 2016.

View of landside looking downstream where the tree has been trimmed up but small starter trees should be removed.

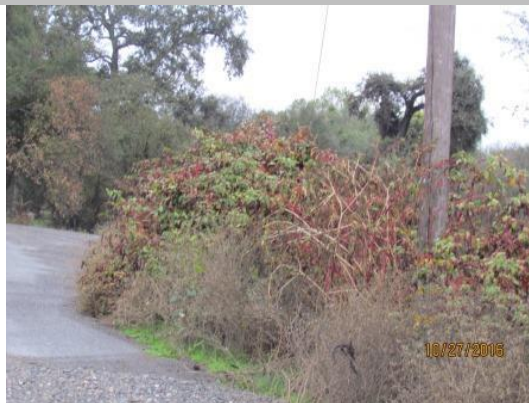
Photo 1 of 1 : SP\_2017\_RD0010\_164\_76\_20170316\_00039.jpg

LM Start	10.70	Rating **	M	Issue No.	76
LM End	10.70	Issue Type +	Ma	Location *	WS
Category	Earthen Levee			GPS Latitude/Longitude	
				Start	End
Item	Vegetation			39.300866 °	39.300866 °
				-121.617510 °	-121.617510 °
DWR ID	DWR_RD0010_02_s_2016_76				
Comment Code					
V4 : Elderberries are blocking visibility and flood fight capability.					
Inspector Comment					
Wild growth on waterside slope should be removed, as appropriate.

View looking downstream at wild growth on waterside slope that needs to be removed.

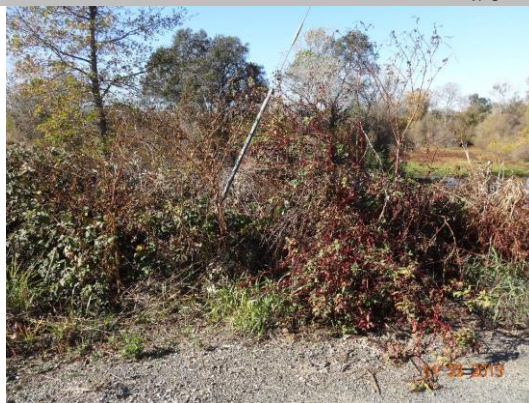
Photo 1 of 3 : UCIP\_SP\_2017\_24839\_44745.jpg

Comment Code					
Inspector Comment					
FS_ID:24839 DS_ID:21304 EP_NO: N/A Repair Type: Non-Urgent Crossing Status: Found UCIP Comments: Rip rap was used to stabilize the waterward slope during high water as a means of emergency repair--unable to determine storm event when repair was performed. Recommend obtaining records of the repair and to determine if crossing is still being used. Need to determine owner. Dense vegetation limits the inspector's visibility to identify signs of pipe failure (leaks) along the slope. Recommend removing vegetation along pipe alignment to conduct proper inspection of structure and appurtenances. This crossing is referenced in the USACE Periodic Inspection as item USACE_CESPK_HON2_2013_p_0458 and 460. FIELD_STRUCT_DESC: 24-inch steel pipe through the levee, 5.0 feet below the crown. Slide gate in a 36-inch concrete riser on the landward shoulder. Gate valve in a pump house on the waterward slope. Concrete headwall, saddle and apron on the waterward end. (USACE-1953). This entry matches the Drainage or Irrigation Structure referenced in O&M manual (Station 655+65). FS Date: 4/30/2013

View of waterward shoulder behind vegetation is standpipe.

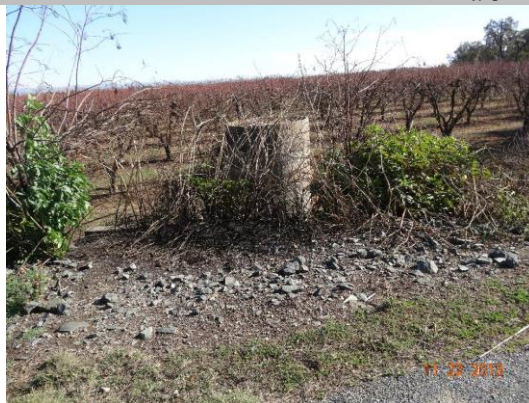
Photo 2 of 3 : UCIP\_SP\_2017\_24839\_44742.jpg

View of standpipe located on landward side.

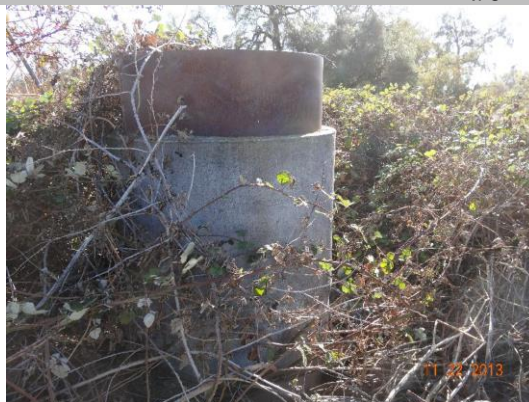
Photo 3 of 3 : UCIP\_SP\_2017\_24839\_44748.jpg

View of standpipe located on waterward side.

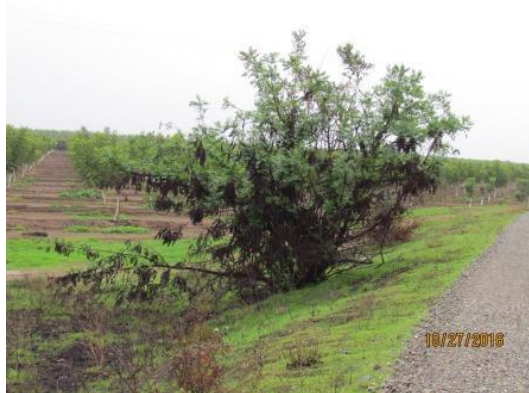
Photo 1 of 1 : SP\_2017\_RD0010\_164\_77\_20170316\_00040.jpg

LM Start	10.79	Rating **	M	Issue No.	77
LM End	10.79	Issue Type +	Ma	Location *	LS
Category	Earthen Levee			GPS Latitude/Longitude	
				Start	End
Item	Trim / Thin Trees			39.302055 °	39.302055 °
				-121.617730 °	-121.617730 °
DWR ID	DWR_RD0010_02_s_2016_77				
Comment Code					
T2 : Thin trees to allow visibility of the ground and room to flood fight.					
Inspector Comment					
Small tree on slope should be removed.

View looking downstream of a small tree on landside slope that should be removed.

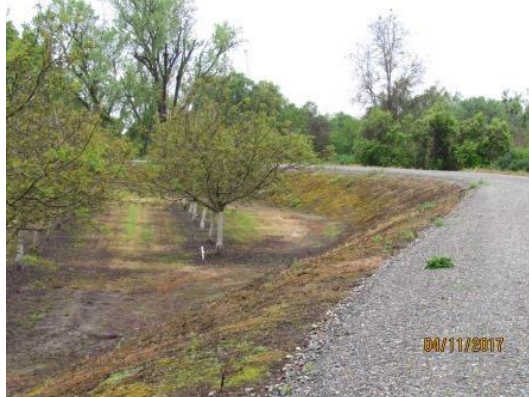
Photo 1 of 1 : SP\_2017\_RD0010\_164\_38\_20170414\_00107.jpg

LM Start	10.81	Rating **	A	Issue No.	38
LM End	10.93	Issue Type +	Ma	Location *	LS
Category	Earthen Levee			GPS Latitude/Longitude	
				Start	End
Item	Vegetation			39.302253 °	39.304036 °
				-121.617922 °	-121.618093 °
DWR ID	DWR_RD0010_02_s_2017_38				
Comment Code					
V1 : Control annual grass and weeds on the levee slopes and easements.					
Inspector Comment					
There are no annual grasses in this section, Spring 2017.

View looking downstream of well maintained annual grasses, Spring 2017.

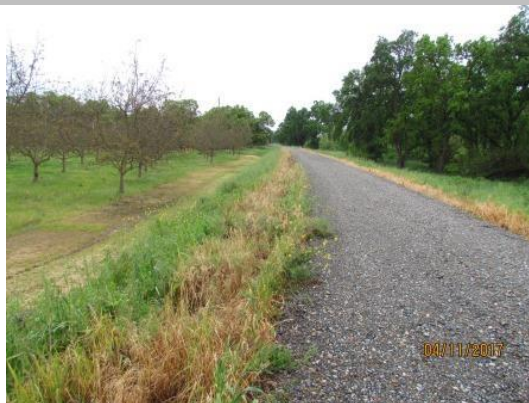
Photo 1 of 1 : SP\_2017\_RD0010\_164\_27\_20170414\_00108.jpg

LM Start	10.93	Rating **	M	Issue No.	27
LM End	11.35	Issue Type +	Ma	Location *	LS
Category	Earthen Levee			GPS Latitude/Longitude	
				Start	End
Item	Vegetation			39.304035 °	39.309862 °
				-121.618095 °	-121.616470 °
DWR ID	DWR_RD0010_02_s_2017_27				
Comment Code					
V1 : Control annual grass and weeds on the levee slopes and easements.					
Inspector Comment					
The annual grasses on the slope needs to be maintained, the crown and shoulders have been sprayed, Spring 2017.

View looking downstream of annual grasses on the slope that needs to be maintained, the crown and shoulders have been sprayed, Spring 2017.
